NASA/TM-2009-215785
NESC-RP-07-47/07-005-E

Space Transportation System (STS)-117 External Tank (ET)-124 Hail Damage Repair Assessment

NASA Engineering and Safety Center Technical Report	Document #: RP-07-47	Version: 1.0
Title:	STS-117 Hail Damage Repair Assessment		Page #: 1 of 113

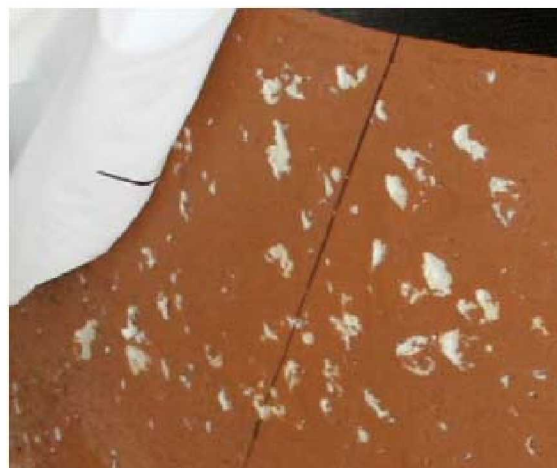
Severe thunderstorms with associated hail and high winds struck the STS-117 stack on February 26, 2007 while at Launch Pad 39. Peak winds were recorded at 62 knots with hail size ranging from 0.3 inch to 0.8 inch in diameter as shown in Figure 6.1-1. The NCFI 24-124 foam on the LO2 tank ogive acreage and the ET intertank incurred significant damage. NCFI on the ET intertank and PDL 1034 foam of the LO2 IFRs suffered minor damage, as did the LO2 tank cable tray SLA. An example of the resulting damage is shown in Figure 6.1-2.

Figure 6.1-2. Example of Hail Damage to ET-124 TPS [ref. 27]

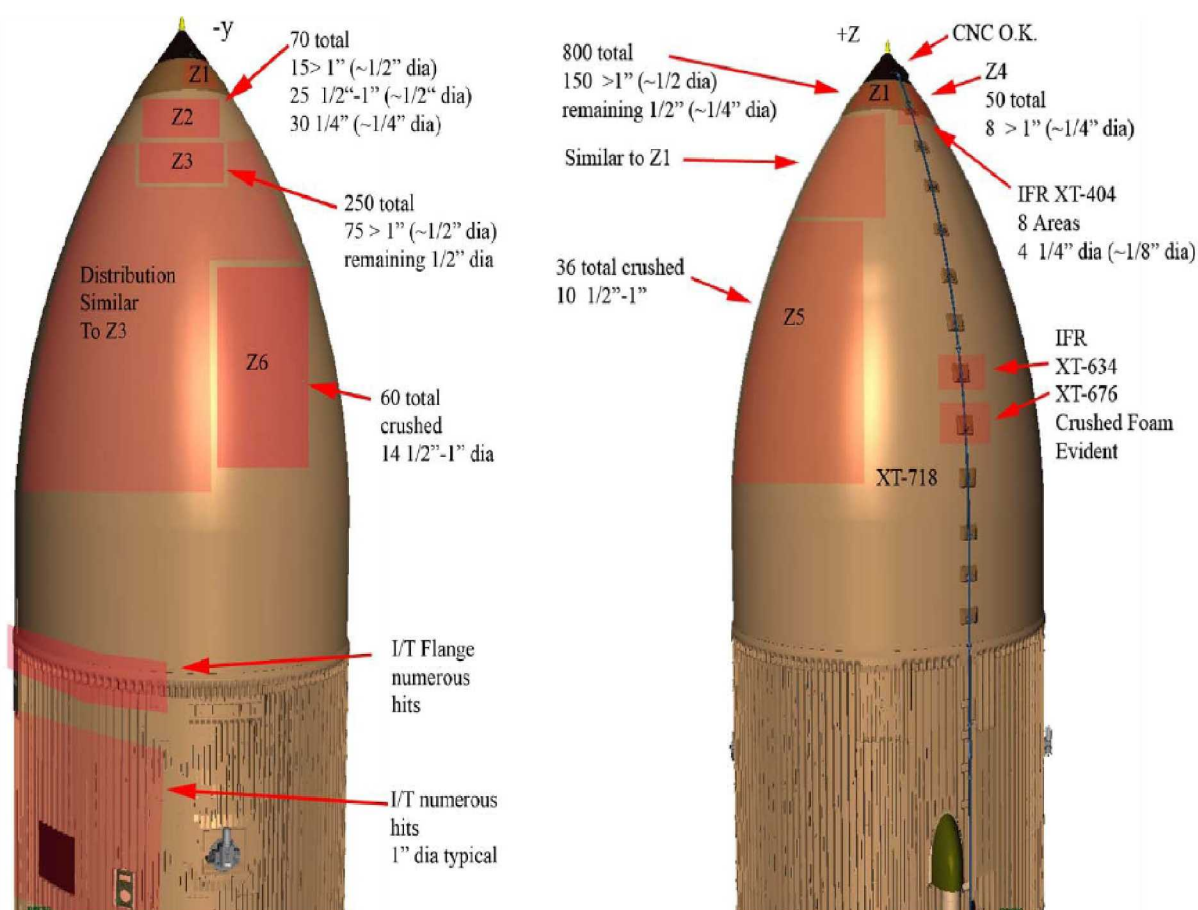
In the initial damage assessment [ref. 3], the ET Project reported that the nose cone and machined surface of the LO2 ogive TPS had suffered a significant number of impacts. As Figure 6.1-3 depicts, impact damage to ET-124 was sustained around the entire circumference with the heaviest concentration on the +Z side with more than 1200 hits. There were numerous areas of damaged foam in the LO2 tank acreage TPS with the heaviest concentration in the +Z and -Y quadrants. Minor damage was observed on the inboard side of all LO2 IFRs with crushed foam observed on the IFRs at stations Xt-634 and Xt-676. Numerous areas of damaged NCFI were observed in the intertank area with the heaviest sustained in the -Z quadrant. Additional less severe damage was also observed in the +Z quadrant. Fewer than 12 hits were observed on the LH2 acreage TPS. Minor damage was observed on the -Y ET / Solid Rocket Booster (SRB) ramp aft fairing and cable tray and on the forward face of the LH2 IFRs.

Figure 6.1-3. Initial Assessment of Hail Damage to ET-124 [ref. 4]

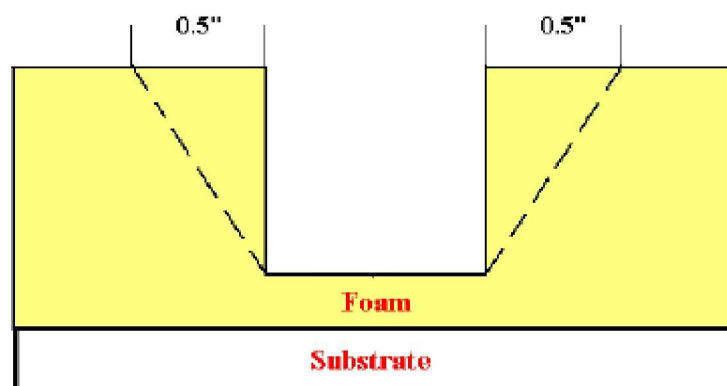
Crushed foam was removed from damage locations less than 0.25 inch in depth and the remaining NCFI thickness evaluated. Sand and blend repairs were implemented at locations where the remaining TPS was sufficient to meet the revised minimum foam thickness criteria. While the 9010 document specifies a 16:1 diameter-to-depth ratio corresponding to a wall angle of approximately 7.5 degrees for repairs of this type, the criteria was modified for ET-124 to minimize removal of adjacent NCFI. The edges of defects up to 0.1 inch deep were slightly rounded. Defects greater than 0.1 inch deep were blended by sanding foam from an area extending no more than about 0.5 inch from the edge of the damage site. Steeper-than-normal wall angles were created in both instances. In another variation from the 9010 requirements, red

Figure 6.2-2. Sand and Blend Wall Angles for Defects > 0.1” Deep [ref. 24]

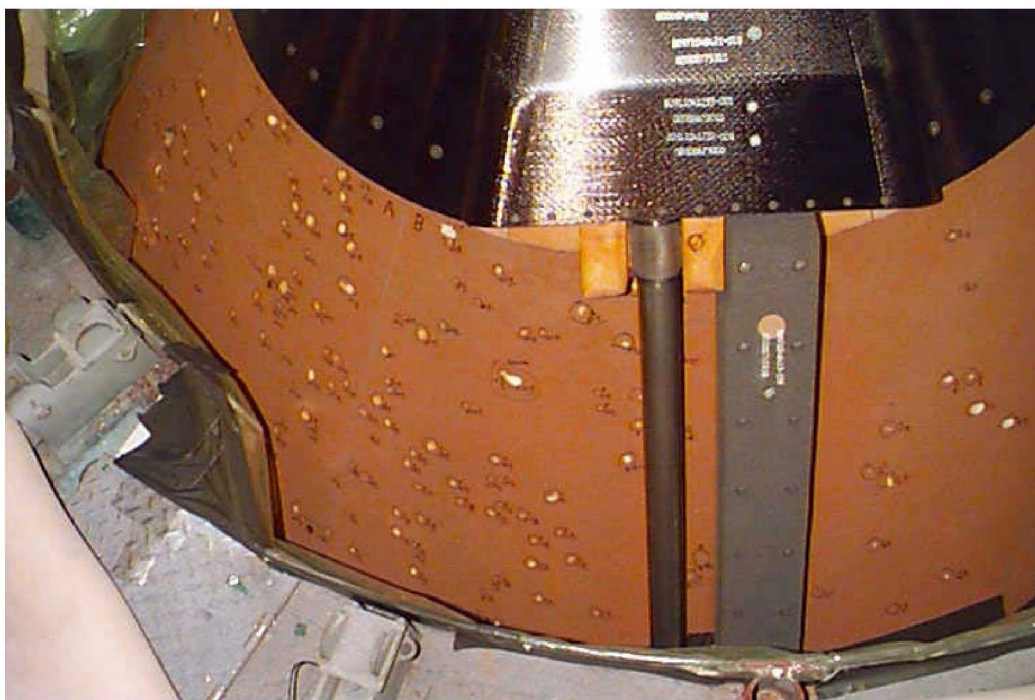
Figure 6.2-3. STS-96 ET-100 Typical Hail Damage

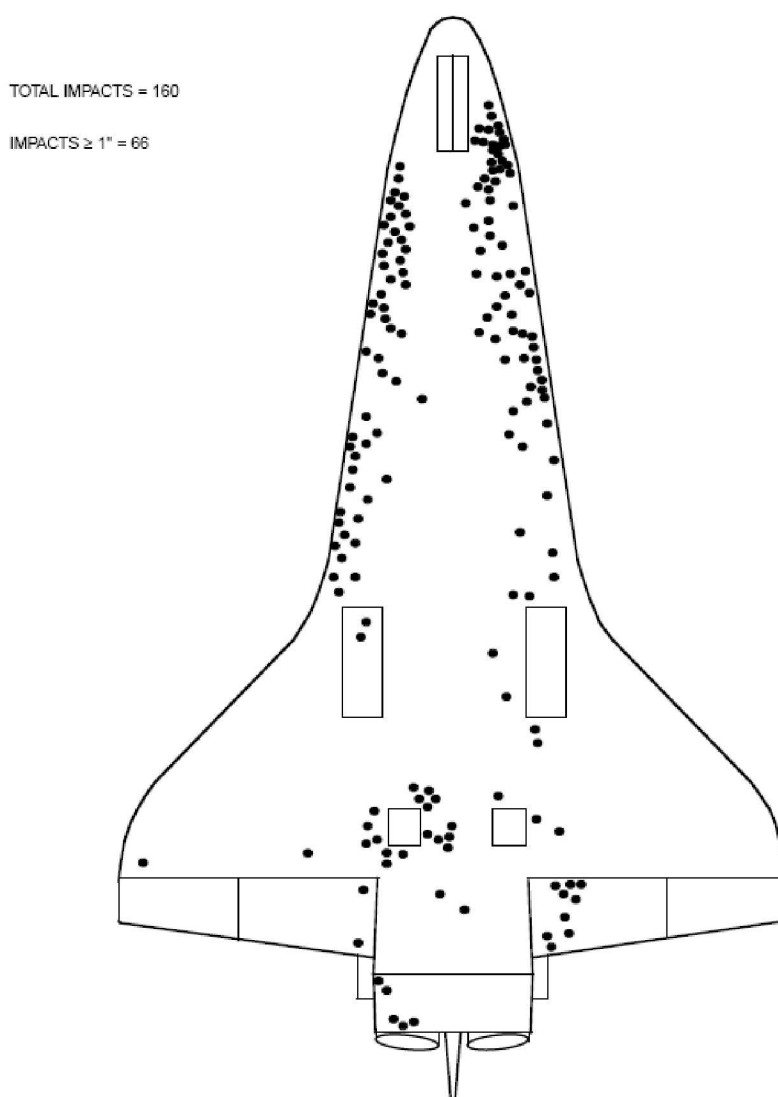
Post-landing debris impact assessment of the Orbiter indicated 160 lower surface hits of which 66 were greater than 1 inch. Boeing's post-landing report for STS-96 [ref. 16], noted that most of the damage was concentrated from the nose gear to the main landing gear wheel wells on both left and right chines as shown in Figure 6.2-5.

Figure 6.2-5. Lower Surface Orbiter Damage

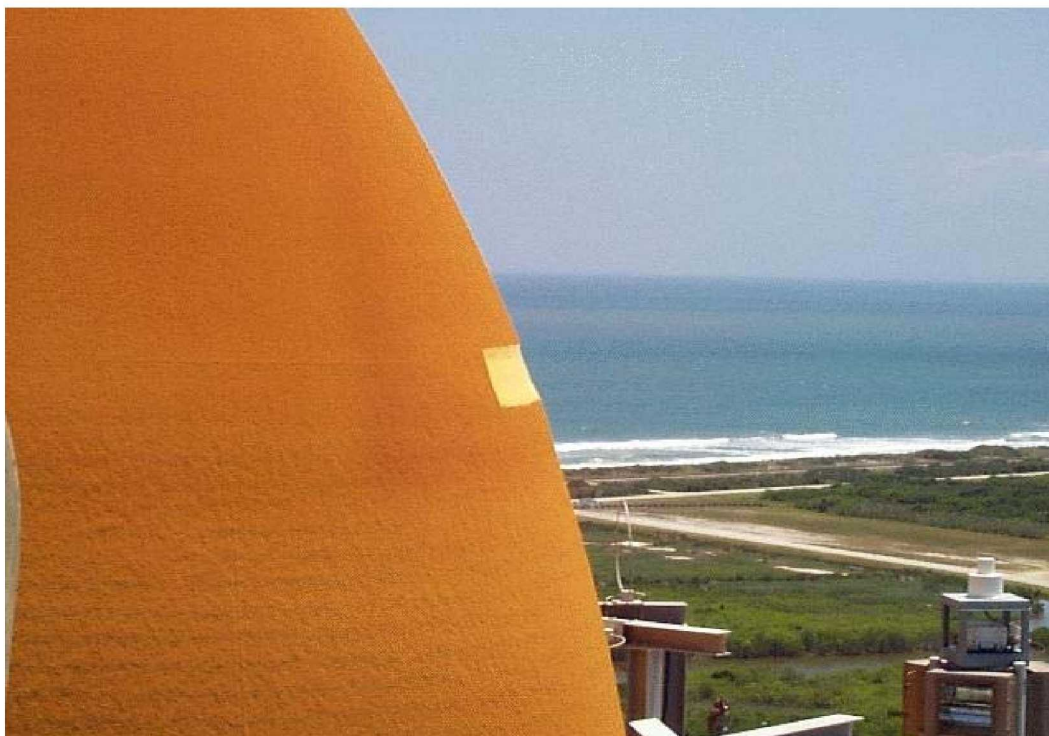
relieve NCFI foam induced compression loading on a LO2 ogive weld joint. The groove was approximately 14 inches wide, by 6 feet length, 1 inch deep; it was created by sanding and blending the NCFI. While the modification created significant surface waviness, flight photos showed no evidence of abnormal erosion or significant foam loss from the LO2 tank (Figure 6.2-8).

Figure 6.2-8. STS-91 LO2 Tank Stress Relief Groove

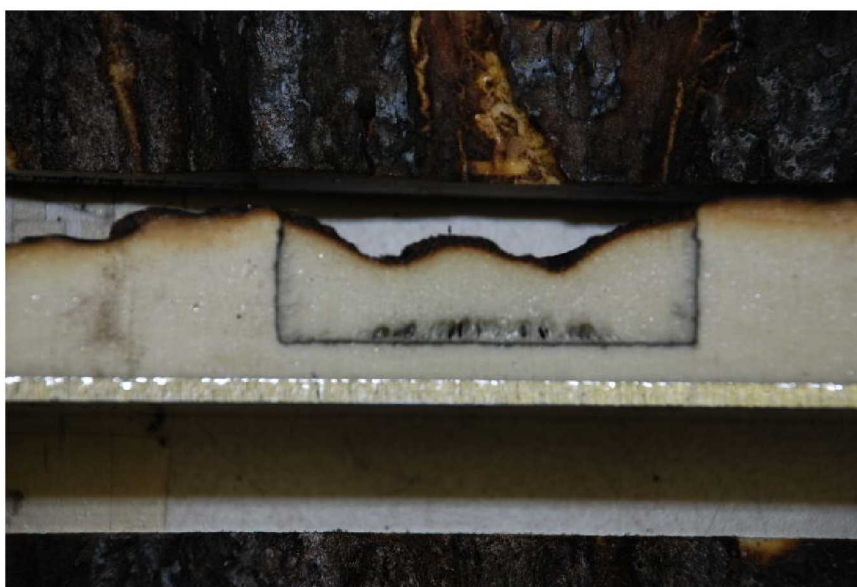
Figure 7.3-7. Sectioned PDL Repair Following Hot Gas Test [ref. 5]

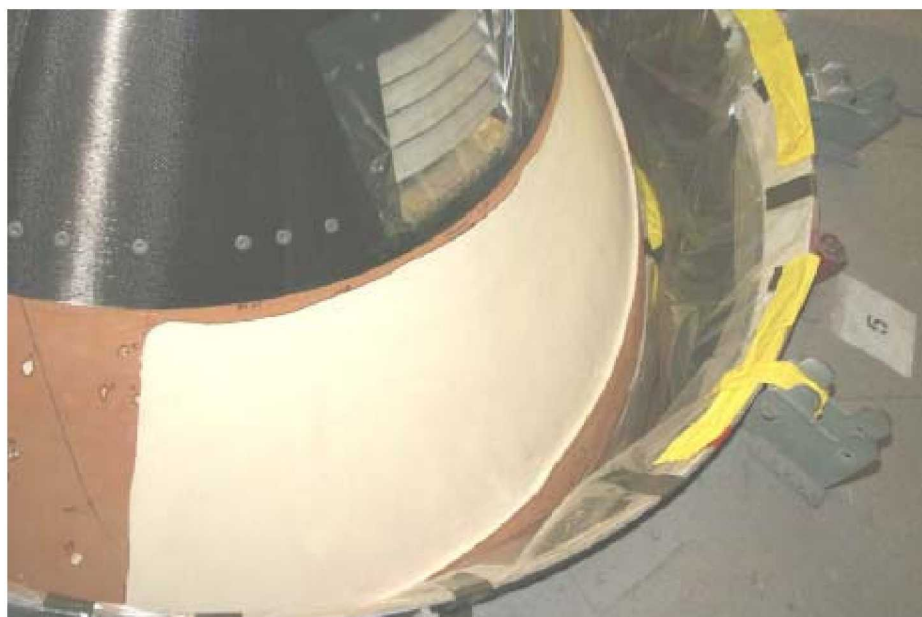
**Figure 7.3-9. Partial View of ET-124 Pencil Sharpener BX-265
Spray Repair Area [ref. 24]**
